Manhole Inspection Summary

Manhole # S43W1_017MH

Insp Date: **6/2/09 2:43 PM**

Location Address: **3400 9thSt. on Chesapeake Ave.**

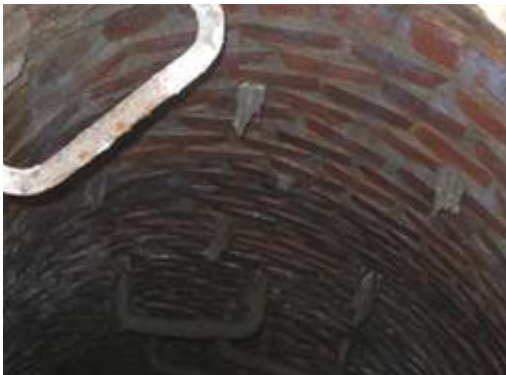
Steps

Count: **6** Missing: **3** ☒ **Corroded**

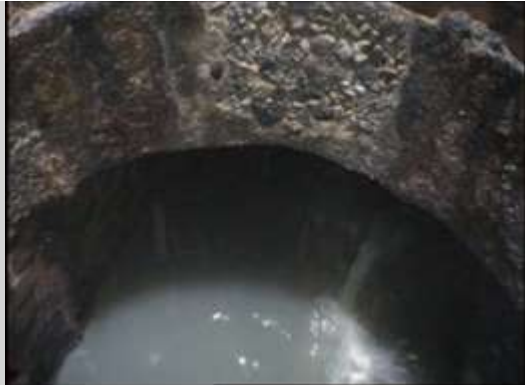
12 O'Clock Outflow

42 in. Circular Gravity Sewer
Pipe Out @ 12 O'Clock

Pipe Height: (in.) Rod and Bar (Angled)
Pipe Material: **Concrete** ☐ Pipe Lined
Invert Depth: (ft.) Flow Characteristics: **Turbulent**
Deposits: ☒ None ☐ Mud ☐ Sludge ☐ Debris ☐ Grease
Silt Depth: (in.) Deposits Extent:
Infiltration: **None** Pipe Seal Cond: **Unknown**

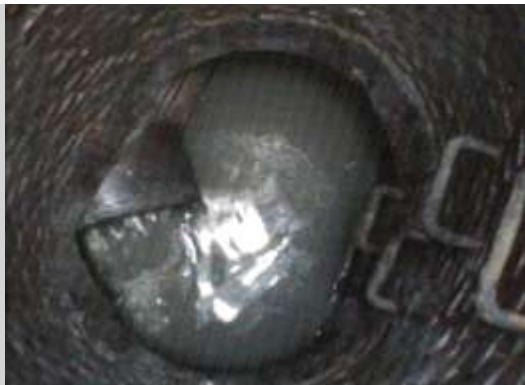
5 O'Clock Inflow

24 in. Circular Gravity Sewer
Pipe In @ 5 O'Clock

Pipe Height: (in.) Rod and Bar (Angled)
Pipe Material: **Unknown** ☐ Pipe Lined
Invert Depth: (ft.) Flow Characteristics: **Turbulent**
Deposits: ☒ None ☐ Mud ☐ Sludge ☐ Debris ☐ Grease
Silt Depth: (in.) Deposits Extent:
Infiltration: **None** Pipe Seal Cond: **Unknown**

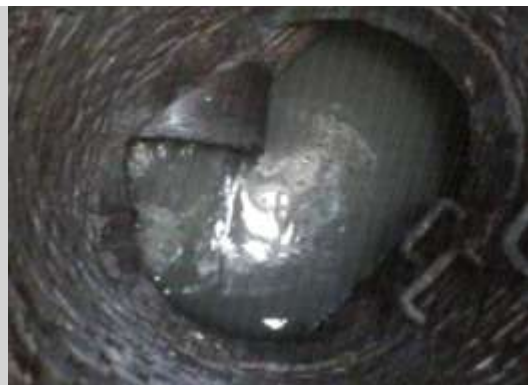
6 O'Clock Inflow

42 in. Circular Gravity Sewer
Pipe In @ 6 O'Clock

Infiltration: **None** Pipe Seal Cond: **Unknown**
